## How to Install Gillpatch®

## Gillpatch® – With Rivets Cargo Liner Repair System For the Repair of Overhead Cargo Compartment Liner Panels in Airbus Aircraft Installation Instructions

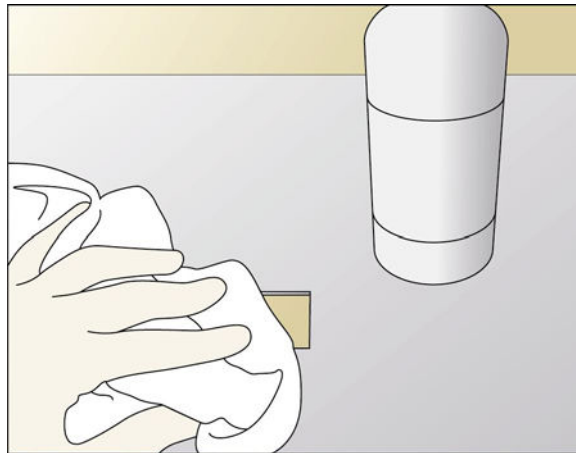
**Figure 1 – Cleaning Damaged Liner Panel**

- 4.1. Clean the surface of the panel to be repaired in the area of the damage; make sure to follow the limits of damage and distance from patch edge to the damage described in the Airbus Aircraft Maintenance Manual (AMM). Use a suitable solvent to remove any grease, oil, or other contamination from the liner surface. Recommended solvents are acetone (propanone), MEK (methyl ethyl ketone), ethanol (ethyl alcohol), or isopropanol (isopropyl alcohol). See Figure 1.

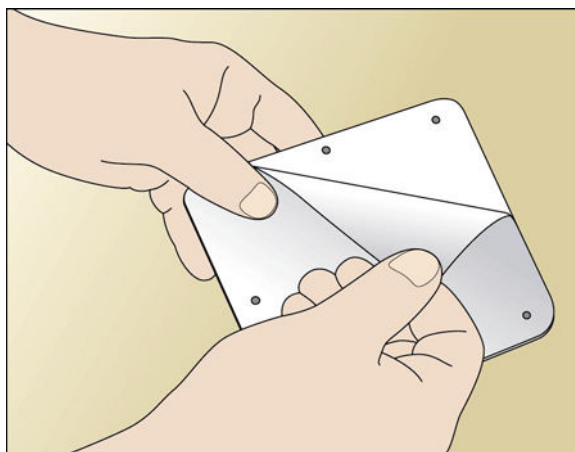
**Figure 2 – Peeling Release Paper Backing**

- 4.2. Carefully remove the release paper from the back of the repair patch to expose the pressure sensitive adhesive; this adhesive is very aggressive, and will hold the patch in place for use as the template for drilling holes in the liner panel. Be careful not to touch the adhesive or allow dust or dirt to settle on the adhesive once it is exposed. See Figure 2.

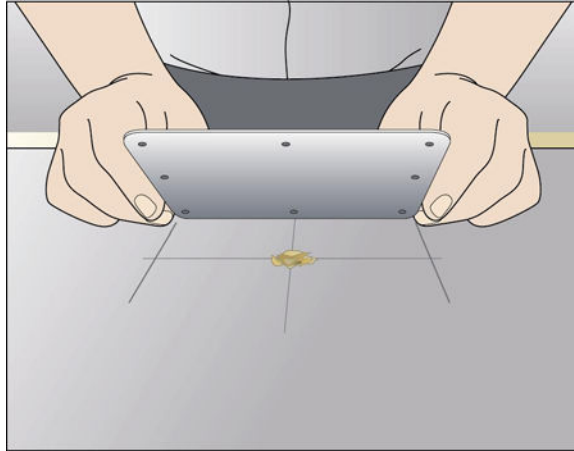
**Figure 3 – Apply Patch Over Damaged Area**

- 4.3. Bond the Gillpatch® in place over the damaged area such that there is a minimum of 38 mm. (1 ½") from the edge of the damage to the edge of the patch, as required by the Airbus repair method. Press the patch firmly in place to ensure adequate adhesion. See Figure 3.

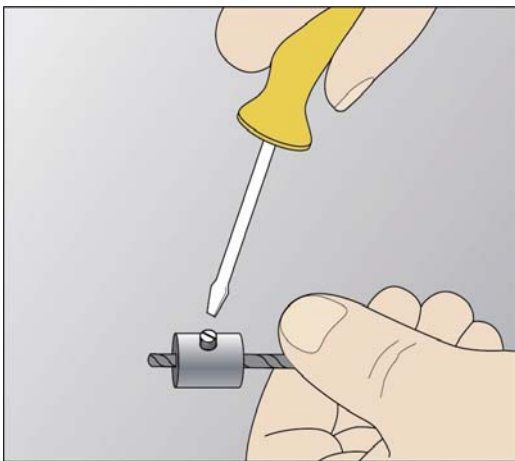
**Figure 4A –  
Setting Drill Stop Collar**

- 4.4. With the patch as a template, the panel is now ready to be drilled to accept the rivets. It is strongly recommended that a stop collar be used on the drill bit to prevent inadvertent drilling through the back of the panel, possibly damaging equipment or fixtures behind the panel. With a drill bit of 3 or 3.1 mm. (0.118 – 0.122 ins) diameter, place a stop collar on the bit as shown in Figure 4A, and adjust it so the maximum drilling depth is limited to 6.4 mm. (1/4 in). Check the drill bit length below the stop collar as shown in Figure 4B.

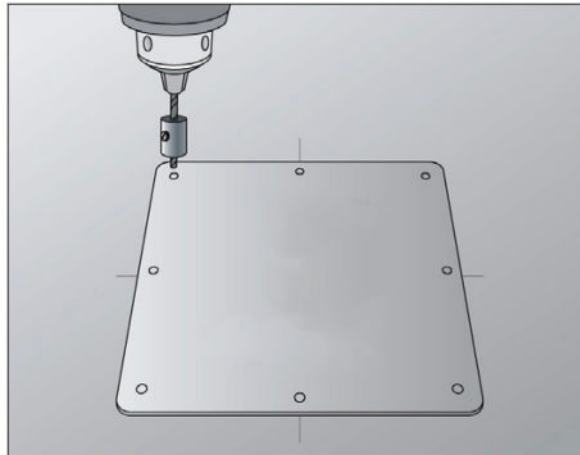
**Figure 5 – Drilling Holes in Liner Panel**

- 4.5. Carefully drill 8 holes in the damaged liner panel, using the attached patch as a template. Use a drill bit of 3 mm. (0.118") or 3.1 mm. (0.122") diameter, and be careful not to cause the holes to become oversized by drilling at an angle or wobbling the drill. The holes are slightly smaller than the diameter of the rivet, but this will ensure adequate pull-out resistance of the rivet after the flange is formed on the inside of the panel facing. See Figure 5.

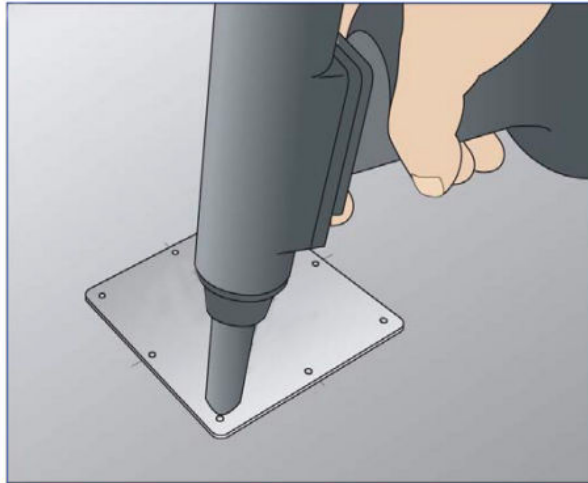
**Figure 7 – Installation of Rivets**

- 4.7. Install 8 rivets in the pre-drilled holes around the edges of the repair patch using a rivet gun such as Cherry Model G784; alternate rivet guns may be used provided they can accommodate the 3.18 mm. diameter rivet with a 31.8 mm. (1 ¼") shaft length. The rivet gun will cause the formation of a flange on the underside of the facing, resulting in strong attachment points, while, at the same time, shear off the shank flush with the face of the rivet. See Figure 7.

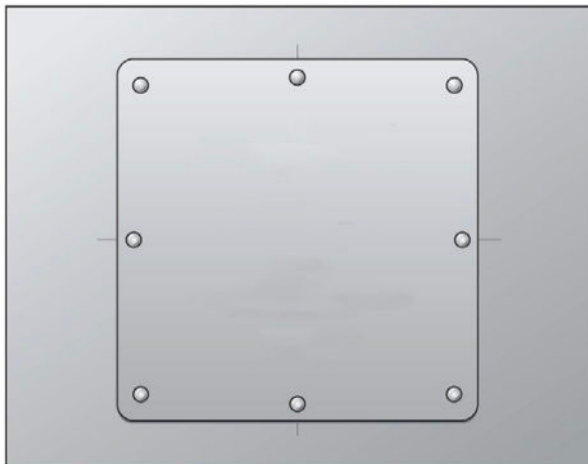
**Figure 8 – Installed Gillpatch® with Rivets**

- 4.8. The finished repair patch installation is shown in Figure 8.

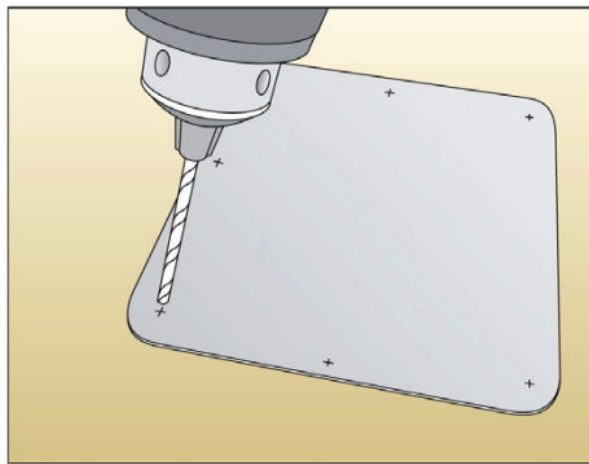
**Figure 9 – Drilling Holes in Gillpatch®**

- 5.1 Place a patch on a suitable surface for drilling, and drill 8 holes approximately 0.156" (5/32", 4 mm) diameter, and  $0.0375 \pm 0.039$ " ( $3/8 \pm 0.039$ ",  $9.5 \pm 1$  mm) from the patch edges. Drill a hole in each corner, and another one halfway between each of the corners, maintaining the distance from the edges. See Figure 9, below.

- 5.2 After drilling the holes in Gillpatch®, follow the instructions shown in section 4, above, for installation of the repair patch. Only the rivet specified in section 4.6 may be used to attach the patch to the liner panel.
