Gillpatch™ Cargo Liner Repair Systems

Gillpatch III

Gillpatch™ III – With Rivets Cargo Liner Repair System
For the Repair of Overhead Cargo Compartment Liner Panels in Airbus Aircraft

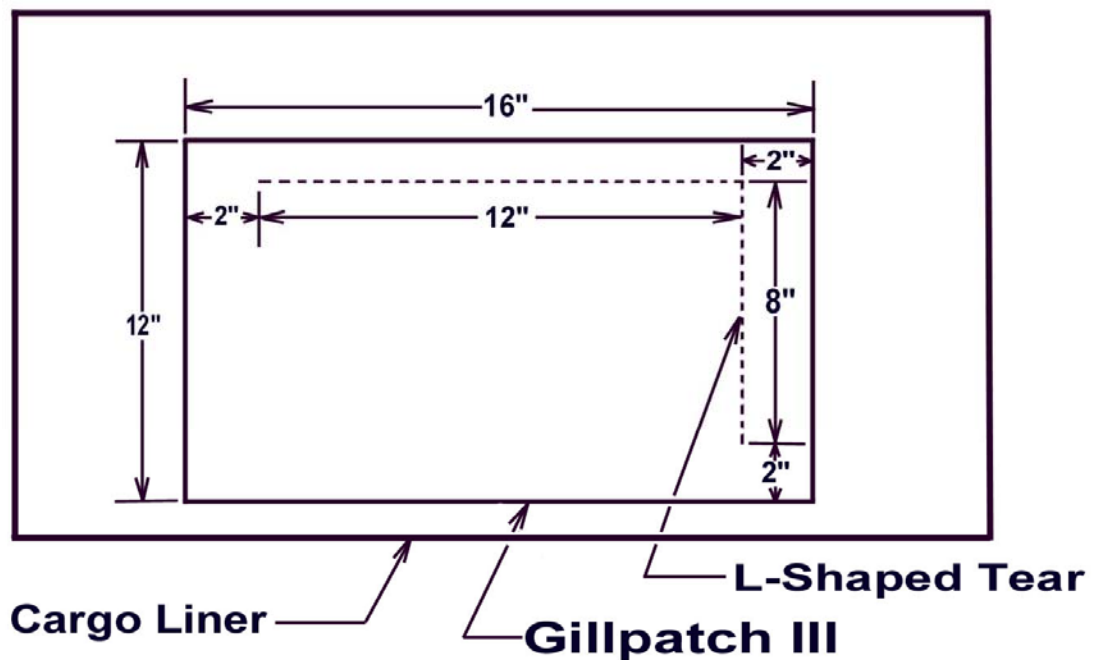
- Center the adhesive side of the patch over the damaged area. Using your hand, apply an even circular rubbing pressure over the entire surface of the patch, including the exposed edges. Make sure the patch is completely adhered to the cargo liner it covers. **The patch must be stuck firmly in place and extend 2 inches beyond all sides of the tear or puncture.** See diagram, below:

Gillpatch III Repair Patch Over Large, L-Shaped Tear

L-shaped tears of up to 12 inches long by 8 inches wide must be covered by a single patch 16 inches long by 12 inches wide, to maintain a minimum 2 inch margin from the edge of the damage. Make sure that the patch repair for any type of damage does not cover a seam, mounting screw, or trim strip -- it must be flat and follow the contours of the liner.

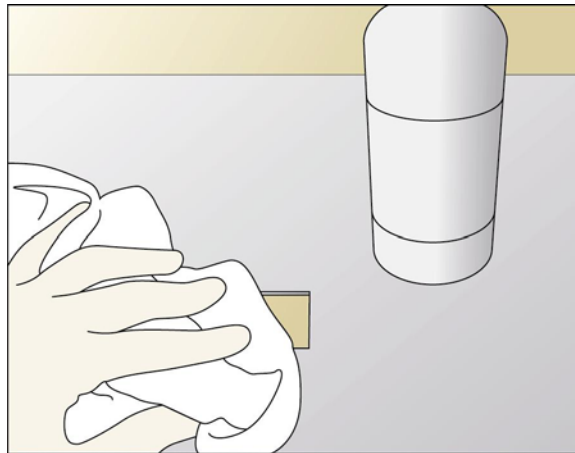
- 4.1. Clean the surface of the panel to be repaired in the area of the damage; make sure to follow the limits of damage and distance from patch edge to the damage described in the Airbus Aircraft Maintenance Manual (AMM). Use a suitable solvent to remove any grease, oil, or other contamination from the liner surface. Recommended solvents are acetone (propanone), MEK (methyl ethyl ketone), ethanol (ethyl alcohol), or isopropanol (isopropyl alcohol). See Figure 1.

Figure 1 – Cleaning Damaged Liner Panel

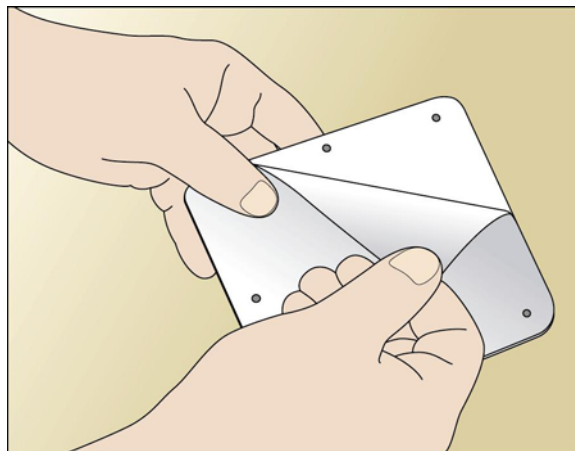
- 4.2 Carefully remove the release paper from the back of the repair patch to expose the pressure sensitive adhesive; this adhesive is very aggressive, and will hold the patch in place for use as the template for drilling holes in the liner panel. Be careful not to touch the adhesive or allow dust or dirt to settle on the adhesive once it is exposed. See Figure 2.

Figure 2 - Peeling Release Paper Backing

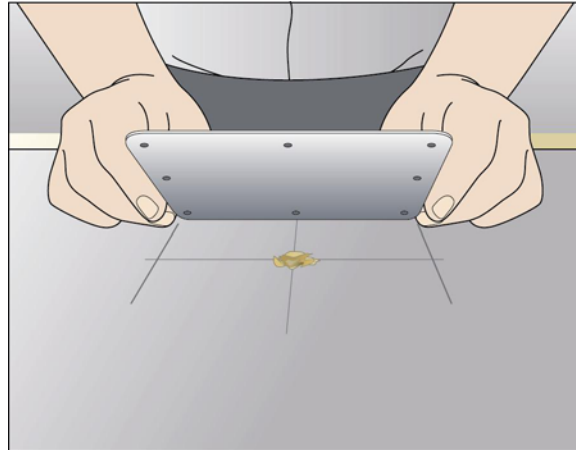
- 4.3 Bond the Gillpatch III in place over the damaged area such that there is a minimum of 38 mm. (1 1/2") from the edge of the damage to the edge of the patch, as required by the Airbus repair method. Press the patch firmly in place to ensure adequate adhesion. See Figure 3.

Figure 3 – Apply Patch Over Damaged Area

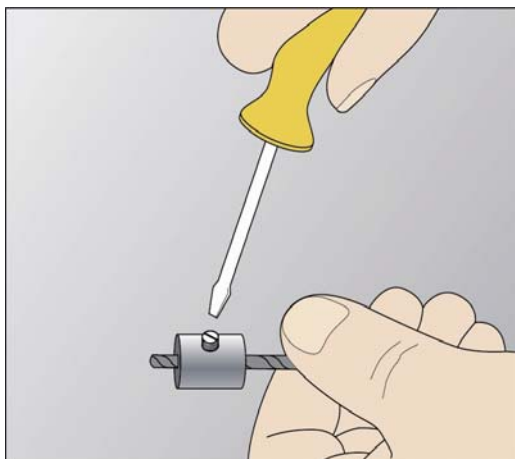
- 4.4 With the patch as a template, the panel is now ready to be drilled to accept the rivets. It is strongly recommended that a stop collar be used on the drill bit to prevent inadvertent drilling through the back of the panel, possibly damaging equipment or fixtures behind the panel. With a drill bit of 3 or 3.1 mm. (0.118 – 0.122 ins) diameter, place a stop collar on the bit as shown in Figure 4A, and adjust it so the maximum drilling depth is limited to 6.4 mm. (1/4 in). Check the drill bit length below the stop collar as shown in Figure 4B.

Figure 4A – Setting Drill Stop Collar

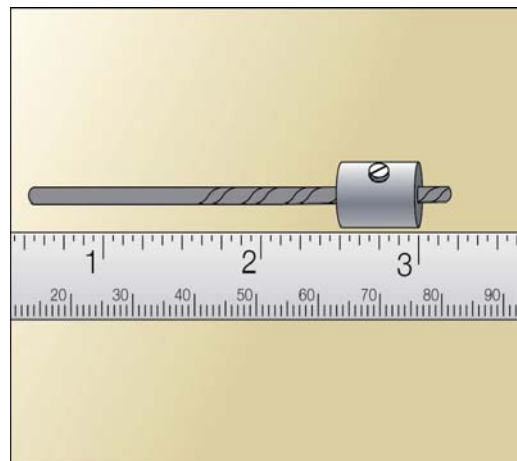
Figure 4B – Checking Drill Bit Depth

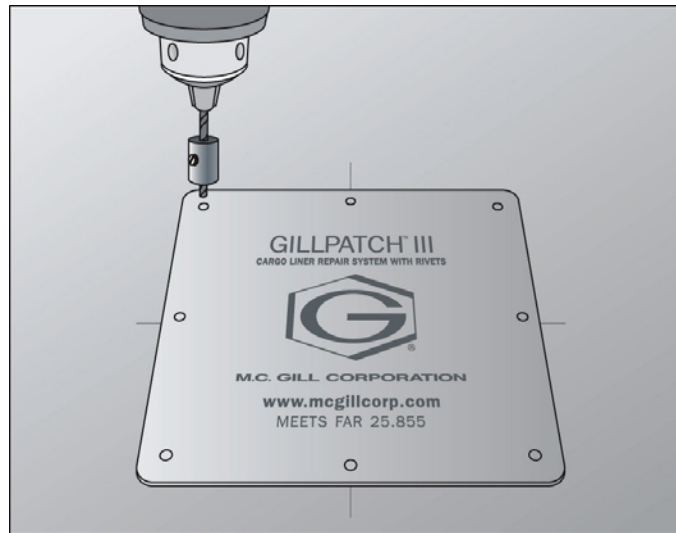
- 4.5 Carefully drill 8 holes in the damaged liner panel, using the attached patch as a template. Use a drill bit of 3 mm. (0.118”) or 3.1 mm. (0.122”) diameter, and be careful not to cause the holes to become oversized by drilling at an angle or wobbling the drill. The holes are slightly smaller than the diameter of the rivet, but this will ensure adequate pull-out resistance of the rivet after the flange is formed on the inside of the panel facing. See Figure 5.

Figure 5 – Drilling Holes in Liner Panel

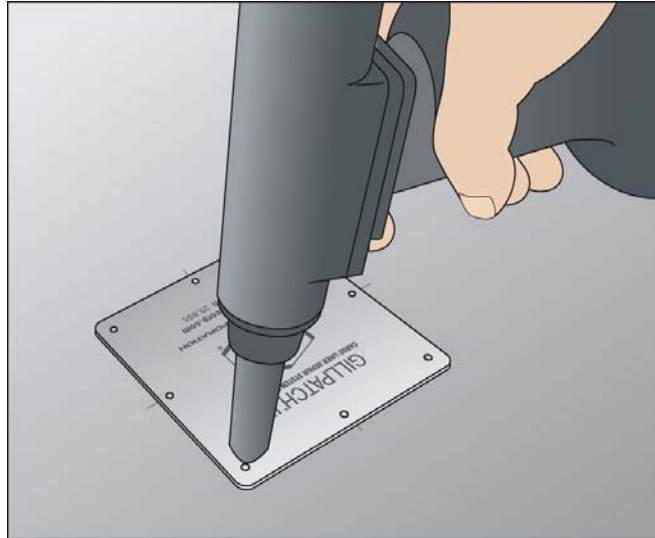
- 4.7 Install 8 rivets in the pre-drilled holes around the edges of the repair patch using a rivet gun such as Cherry Model G784; alternate rivet guns may be used provided they can accommodate the 3.18 mm. diameter rivet with a 31.8 mm. (1 ¼”) shaft length. The rivet gun will cause the formation of a flange on the underside of the facing, resulting in strong attachment points, while, at the same time, shear off the shank flush with the face of the rivet. See Figure 7.

Figure 7 – Installation of Rivets

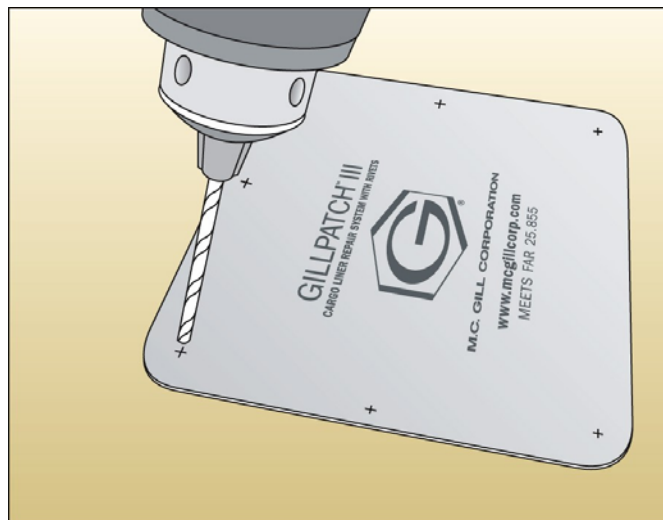
- 5.1 Place a patch on a suitable surface for drilling, and drill 8 holes approximately 0.156” (5/32”, 4 mm) diameter, and 0.0375 ± 0.039” (3/8 ± 0.039”, 9.5 ± 1 mm) from the patch edges. Drill a hole in each corner, and another one halfway between each of the corners, maintaining the distance from the edges. See Figure 9, below.

Figure 9 – Drilling Holes in Gillpatch III
